**SAS Superstructure**

Location: 04-SF-80-13.2 / 13.9

Daily Diary Report by Bid Item

Diary #: 757 Const Calendar Day: 220 Date: 10-Jan-2013 Thursday

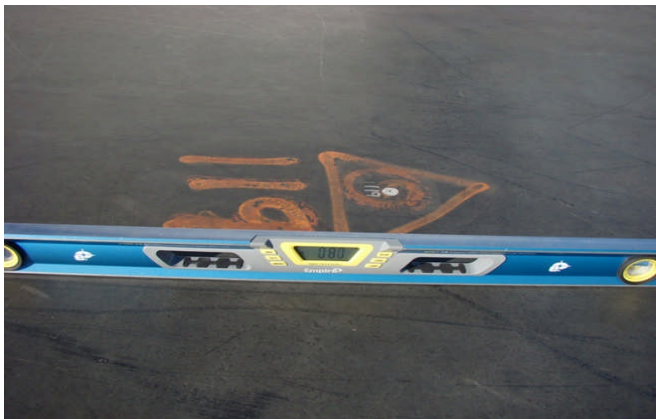
Longitudinal slope of 0.8 degrees measured with the SMART level along the W-Line near WPP119CL.

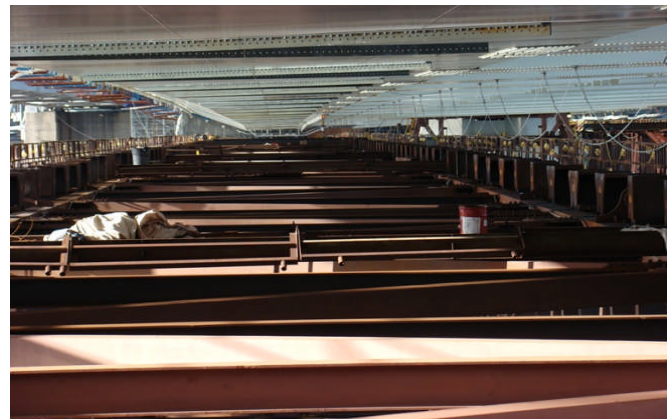
Craddle removal has been complete on the temporary truss, the photo was taken from the E2 cap beam of the E-Line truss looking west.

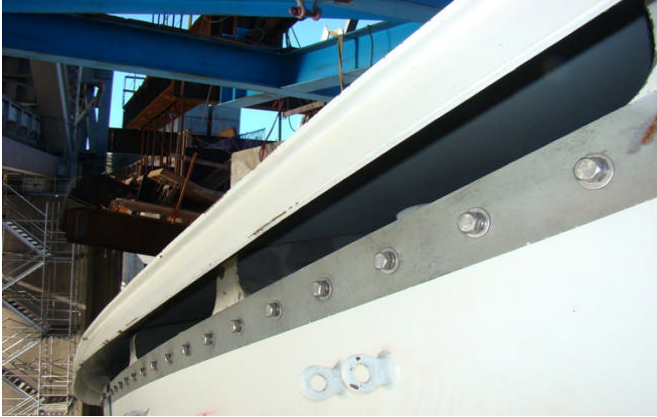
- Briefly inspected how measurements could be taken on at the west deviation saddle between the top cover plate and the side cover plate bolt configuration. To reiterate this is being done to potentially add a steel plate to prevent birds from entering this area, see the photo below for more details on this issue.

Gap of the E-Line west deviation saddle top and side cover plates which needs a barrier to prevent birds from entering this area.

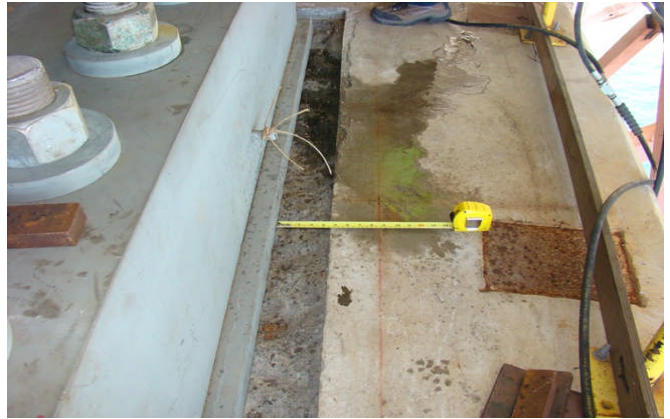
- Checked on the progress of the Shear Key and Bearing survey prior to grouting operations. ABF is currently water testing the S3 and S4 Shear key anchor rod blockout bottom forms, see photo below for more details. Approximately at 10:00am I was informed by ABF engineer Zach Lauria that the B1 and B3 bearing lower housings were rotated and square with the west survey lines, see photo below for more details. I checked the offset from the west survey line on the E2 concrete surface and the lower housings were within acceptable tolerance.

As the additional inspection of the bearings at the E2 cap beam were performed, it was discovered that the gap between the lower and upper housings of the bearings were not 20mm +/- 2mm. I consulted with Bob Brignano on this issue since he knows the extensive history on the fabrication and installation of the bearing/shear key components. We agreed that ABF needed to correct this issue prior to grouting and I showed ABF engineer Zach Lauria this issue. He was reluctant to move the lower housings when informed because he thinks that applying force to this component could damage some of the structural members.

B1 bearing lower housing alignment in relation to the survey lines set on the west side of the E2 cap beam.

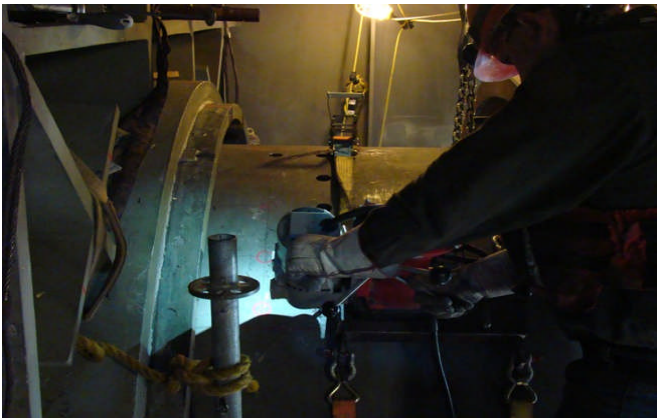
ABF ironworkers didn't place any restraint brackets for centerpunching/markings instead they spent most of the day drilling holes at the following restraint bracket locations:

ABF ironworker drilling holes for the restraint bracket on the top of pipe beam AE-N east of diaphragm B.

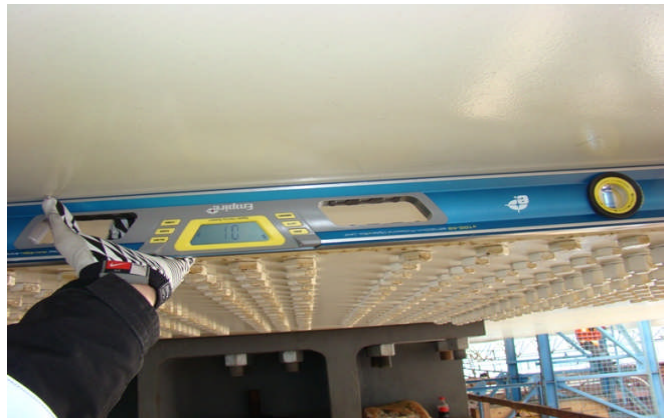
Longitudinal slope of 1.0 degrees measured with the SMART level on the bottom side of the OBG near the S3 Shear looking south.

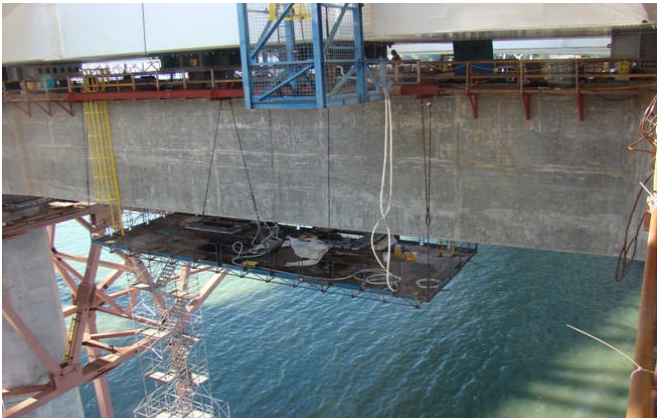
Water testing the S3 and S4 anchor rod blockouts prior to grouting operations.
